## MARINE SAFETY ALERT

Alert 6-08

### COUNTERFEIT EMERGENCY ESCAPE BREATHING DEVICES (EEBDs)

Alert 7-08

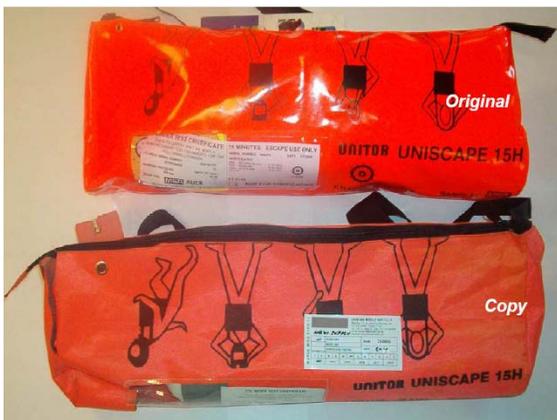
An authentic Unitor UNISCAPE 15H is contained in a shiny PVC bag. When viewed from the front with the instruction icons upside down, the zipper opens from left to right, and at the most left section of the zipper is a two centimeter gap covered by a clear tab that has a button closure.

The **fake reproduction** is contained within a **dull canvas-like** material bag. When viewed from the front with the instruction icons upside down, the **zipper opens from right to left**, and at the most left section of the zipper there is no opening, although a tab made of what appears to be the same material of the bag is present with a button closure. This unit will not automatically activate.

The U.S. Coast Guard has recently learned that counterfeit Unitor model UNISCAPE 15H EEBD Emergency Escape Breathing Devices (EEBDs) are being sold to ship operators and placed onboard commercial vessels. The U.S. Coast Guard **strongly encourages** that all vessel owners and operators with EEBDs onboard carefully and thoroughly inspect them for authenticity. If any doubt exists as to the authenticity, they should immediately contact their emergency equipment vendors and / or the manufacturer for verification or replacement.

The number of fake units sold and currently onboard vessels is unknown and could be substantial. The fake reproduction will not fit over an individual's head and the automatic air release valve will not open. A crisis situation requiring the use of an EEBD will be severely compounded, potentially leading to death, should a crewmember inadvertently rely on a fake reproduction.
